> UM-3731-98 1998 Chevrolet Camaro

# In-depth Vehicle Occupant Report

The University
of Michigan
Transportation
Research Institute

Case Vehicle (A): 1998 Chevrolet Type: Camaro, 2-door coupe

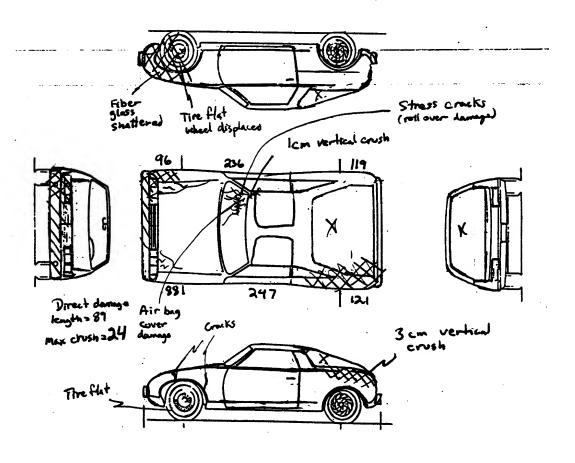
### **VEHICLE DAMAGE**

(Slides 10, 11, 12, 13, 14) Damage to case vehicle (A) was moderate. Direct-damage length from the frontal impact was 89 cm and began at the right-front bumper corner. Maximum crush was 24 cm and occurred at the right-front bumper corner. The front bumper, right headlight assembly, radiator, and both fenders were damaged. The right-front wheel was displaced 31-cm rearward, and this damage probably caused the airbag to deploy. The hood was damaged, and the hood latch released. Both of the hood hinges were damaged, the rear edge of the hood was elevated, but did not contact the windshield.

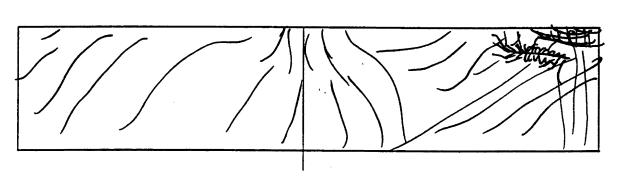
As a result of case vehicle (A) rolling over, the right upper A-pillar and left and right-upper B-pillars were damaged, and there was minor deformation of the right side of the windshield header with associated stress cracks in the windshield. The left quarter panel was crushed vertically and the left fiberglass outer door skin was missing from the vehicle. (Slides 15, 16, 17) The hatchback frame was torn from the vehicle and the rear window was shattered. The hatchback striker post mount separated from the body of the vehicle and was found attached to the latch.

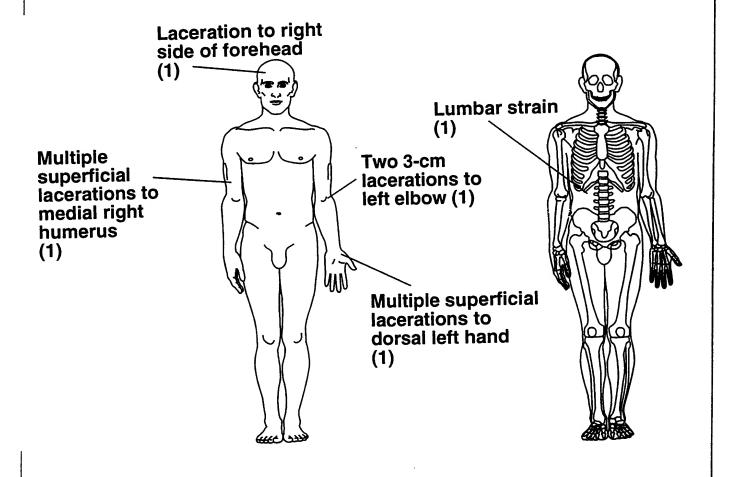
#### INDICATE LOCATION OF INJURIES.

(Slides 30, 31) The 18-year-old male driver was reportedly wearing the available three-point belt and the airbag deployed. During the frontal impact, he moved forward and to the right relative to the vehicle and into the deploying airbag. (Slides 32, 33, 34, 35) He sustained a laceration over the right side of his forehead, possibly from contact with the roof/T-top. He sustained two 3-cm lacerations to the left elbow, and multiple superficial lacerations to the dorsal left hand and medial right humerus, probably from flying glass. He also sustained a lumbar strain due to impact forces.

I		Injury Source	
Injury Description	A.I.S.	Definite	Probable	Possible
Laceration to the right side of forehead	1			Roof/T-top
Two 3-cm lacerations to the left elbow	1		Flying glass	
Multiple superficial lacerations to dorsal left hand	1		Flying glass	
Multiple superficial lacerations to right medial humerus	1		Flying glass	
Lumbar strain	1	Impact forces		
	}			
Maximum A.I.S. Level	1			
Injury Severity Score	2
